Structural Condition Analysis and Assessment of Dormitory Facilities

December 17, 2019

Site Located at 820 Ka'ahumanu Avenue, Kahului, Maui 96732 TMK: (2)3-8-07:117

Summary of Structural Field Condition Survey for the Existing University of Hawaii Community College Dorm Campus Buildings and Appurtenances

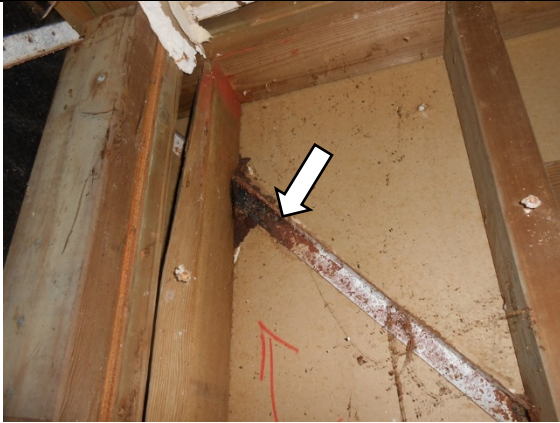
PA1D.1: Typically, metal wall braces exhibit minor to moderate rust.

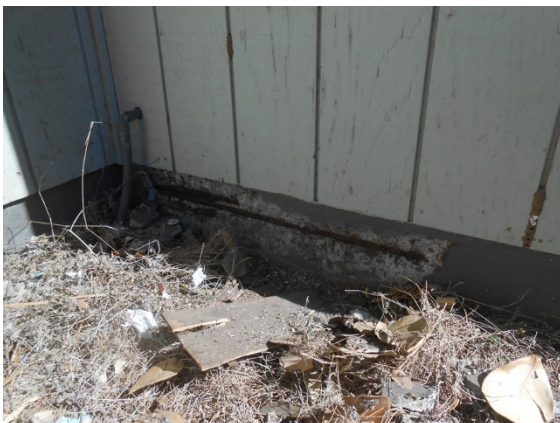
PA1D.2: At various locations, exterior foundation wall face is spalled with exposed corroded reinforcing steel.

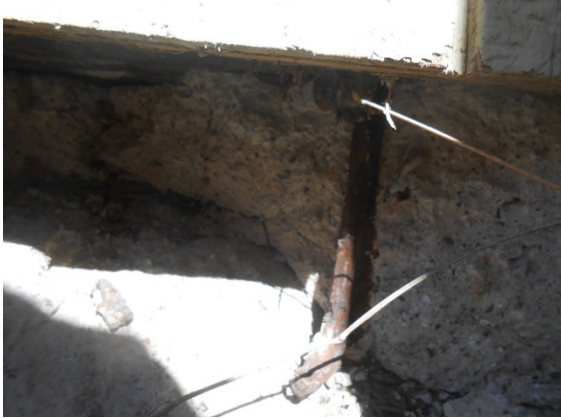
PA1D.3: Concrete spall with exposed corroded sole plate anchor rod.

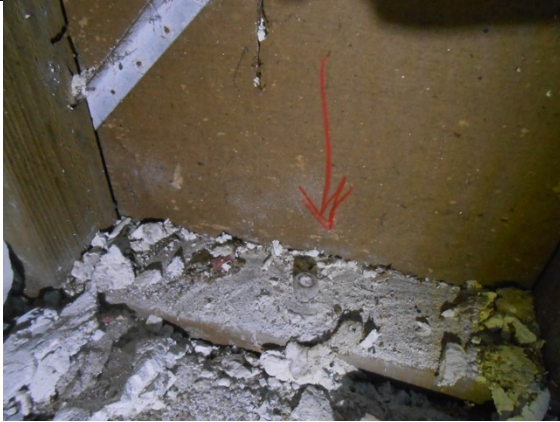
PA1CD.1: At various locations, sole plate anchor rods nuts are loose.

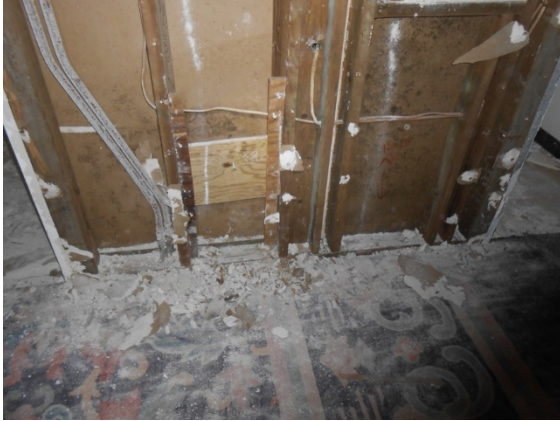
At various locations, interior wall sole plate anchor rods are missing or installed with spacing greater than 32" on-center.

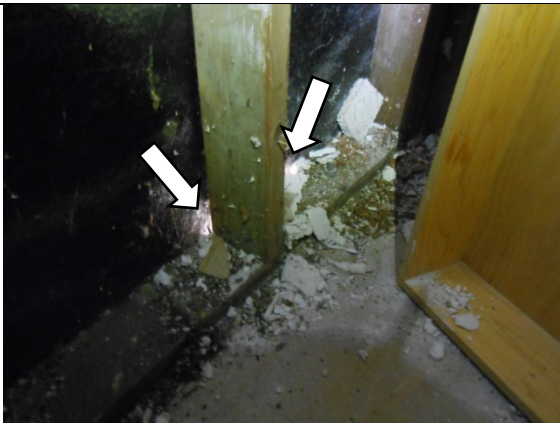
PA1CD.2: Daylight observed at base of wall.

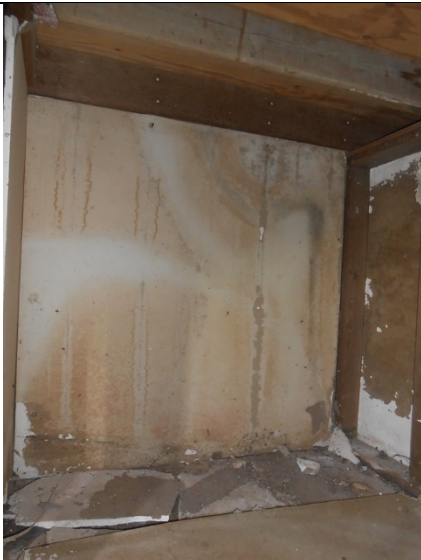
PA1CD.5: Stud wall framing not in-place beneath stair landing at exterior wall.

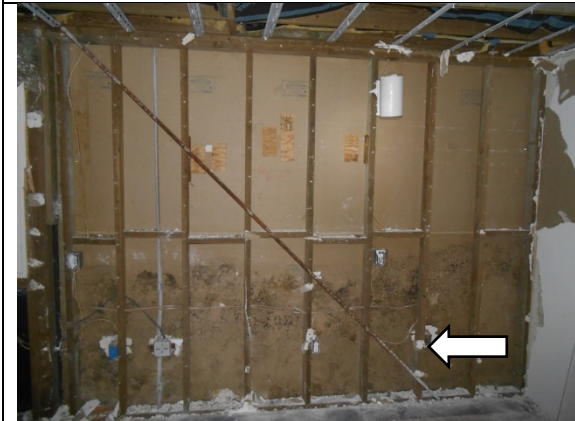
PA1CD.8: Discontinuous stud.

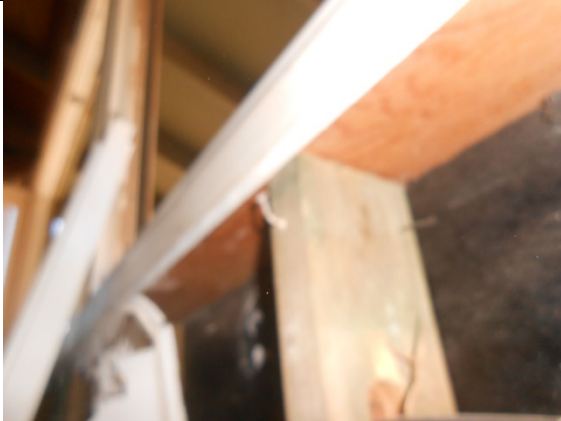
PA2CD.2: Missing opening sill plate. Window supported on studs.

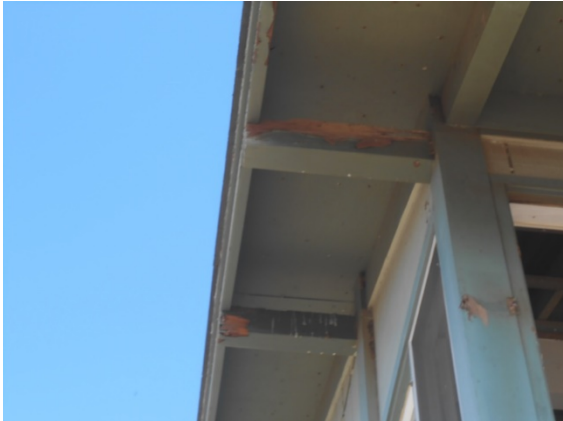
PARD.1: Beam overhang dry rot.

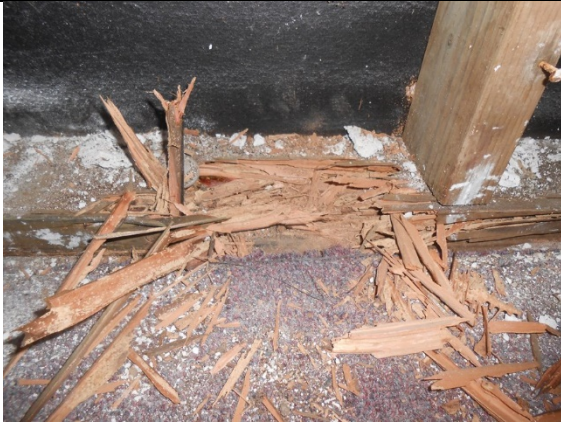
PB1D.1: Sole plate dry rot.

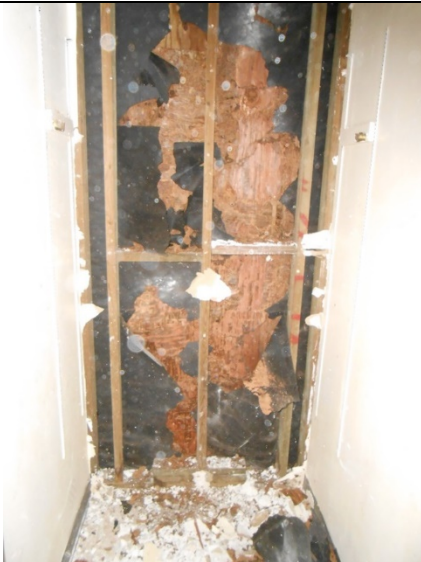
PC1D.3: Siding dry rot.

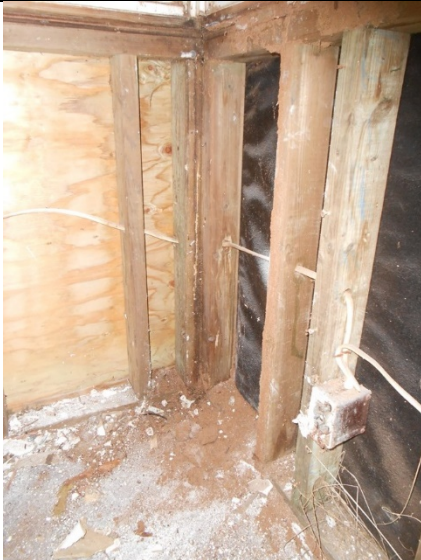
PC1D.6: Termite mud tracks on member surfaces.

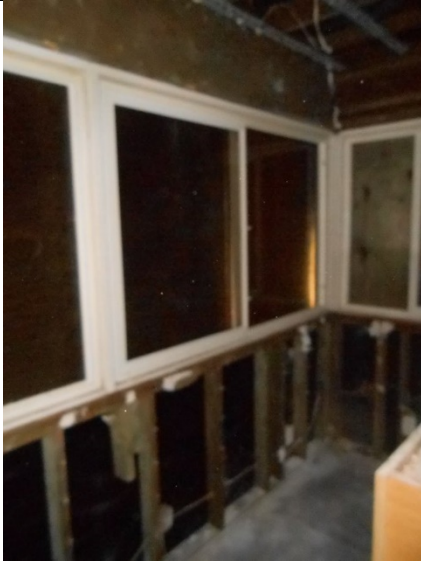
PC1CD.2: Wide opening with single sill plate.

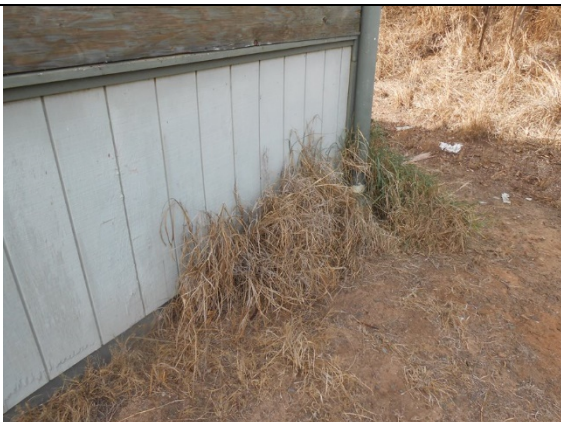
PC1CD.3: At various locations, vegetation against building façade.

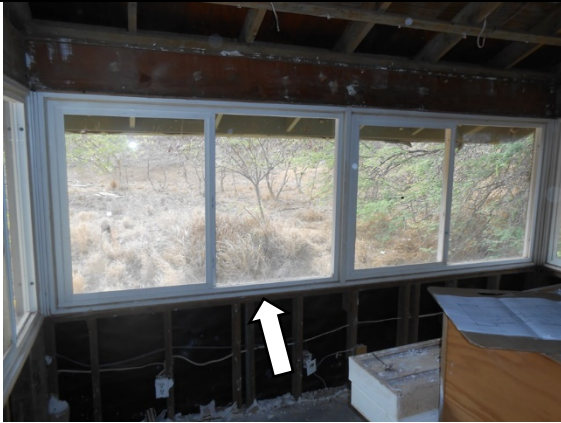
PC2CD.2: Wide opening with single sill plate.

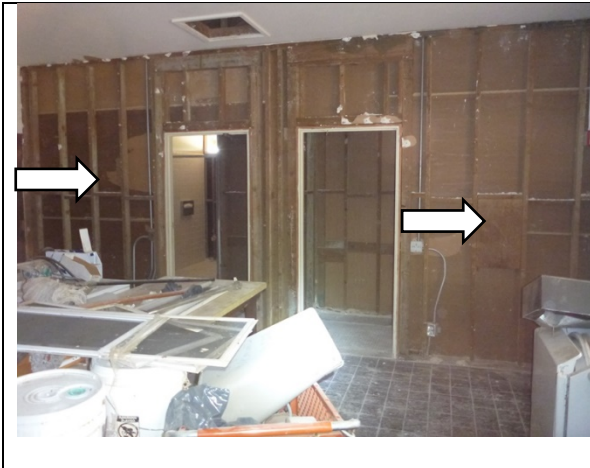
RC1CD.3: At various locations, let-in braces are not installed as shown per the original structural drawings.

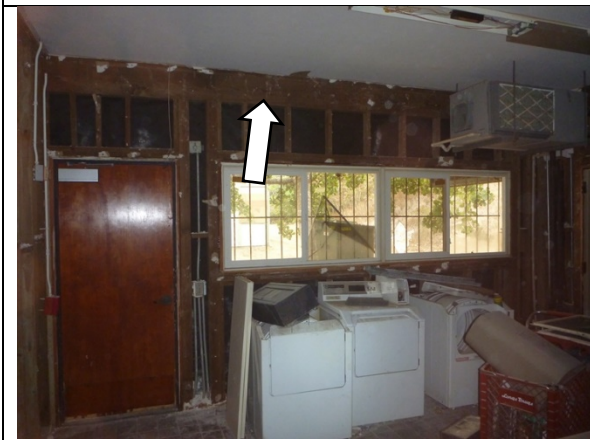
RC1CD.4: At various locations, headers are installed as continuous members spanning over multiple openings. The original drawings specify an individual member over each opening.

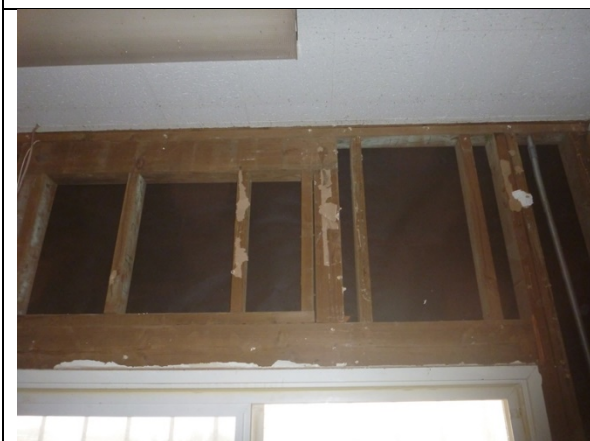
RCICD.5: Odd framing above office window.

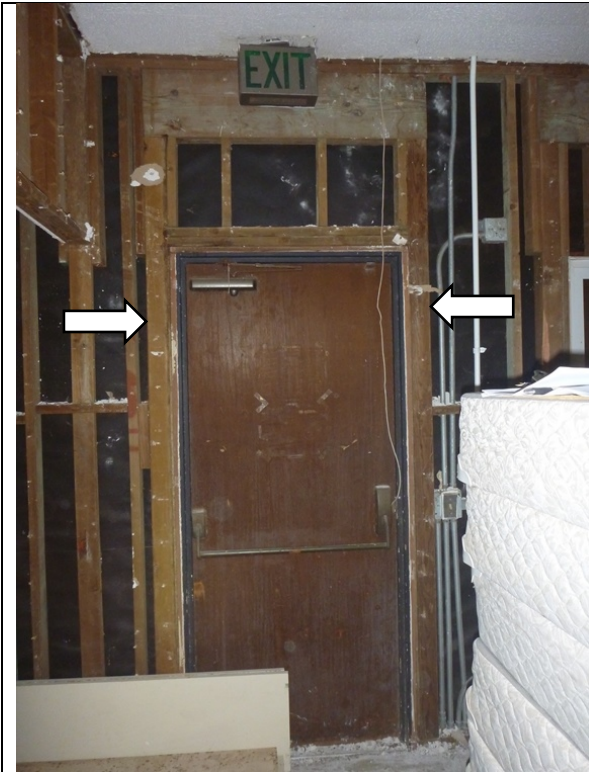
RCICD.6: At various locations, scab (aka king post) is not installed against the jamb post as specified per the original structural drawings.
