Subject: **COMMUNITY PLAN AMENDMENT AND CHANGE IN ZONING FOR MAALAEA AGRICULTURAL SUBDIVISION (PSLU-41)**

**POHAKEA WATERSHED / MA'ALAEA BAY  
MAUI COUNTY, HAWAII  
STORMWATER MANAGEMENT PLAN**

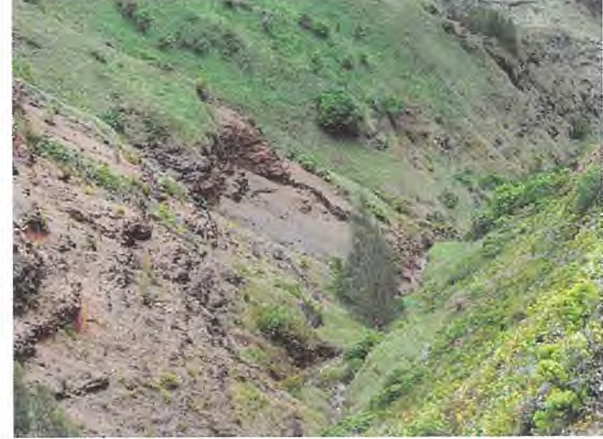
Land Slide into Gulch

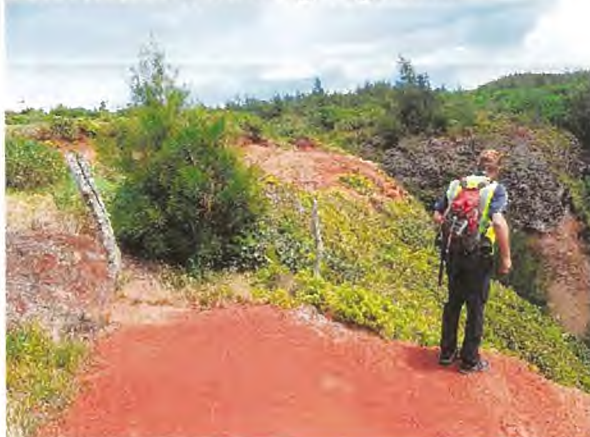
Bare Ground Areas

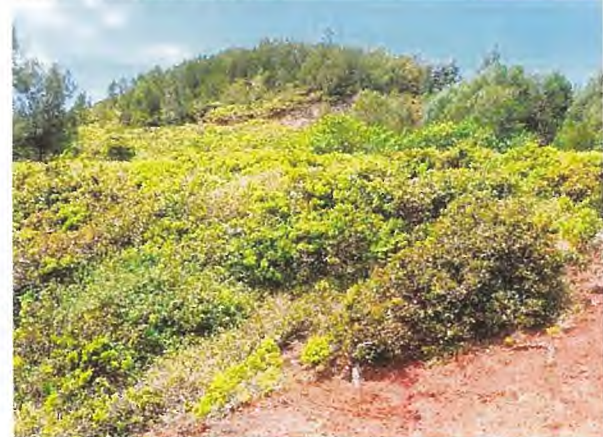
Bare Ground and Native Vegetation

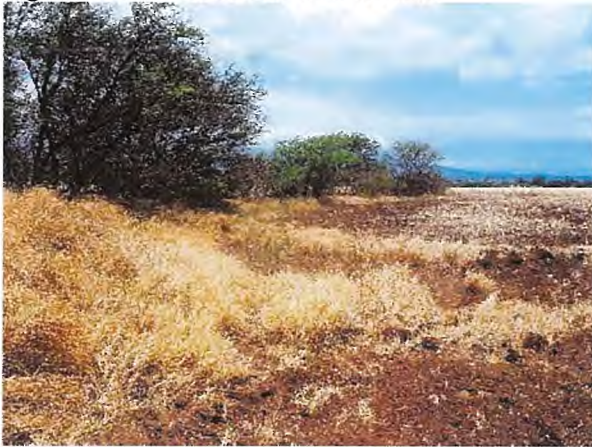
Fallow Agricultural Land

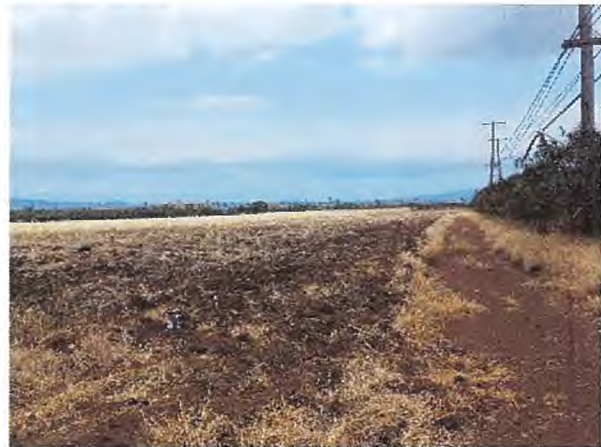
Agricultural Roads and Fire Breaks

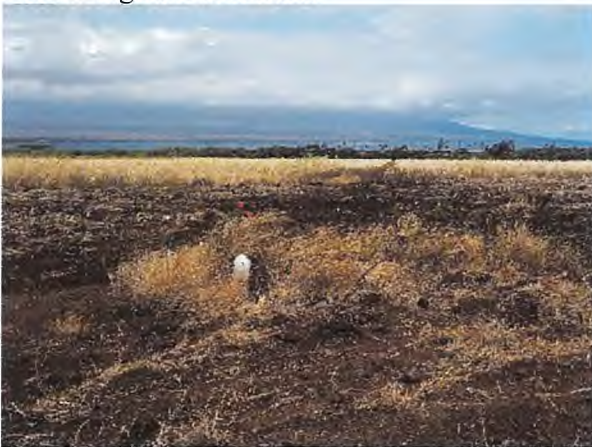
Fire Breaks

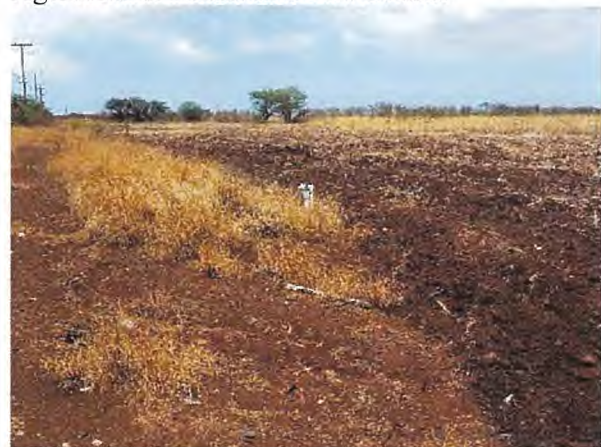
Agricultural Road with Fire Break

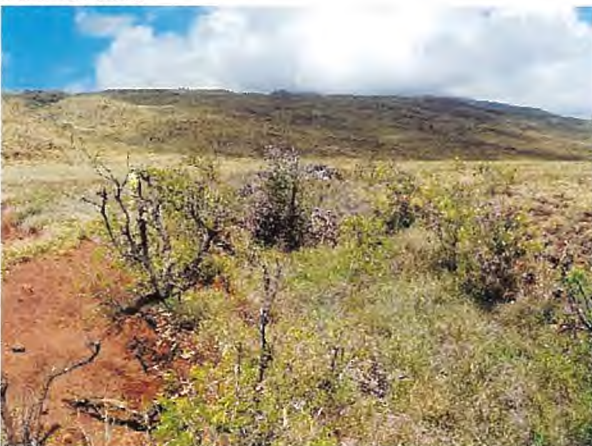
Agricultural Road

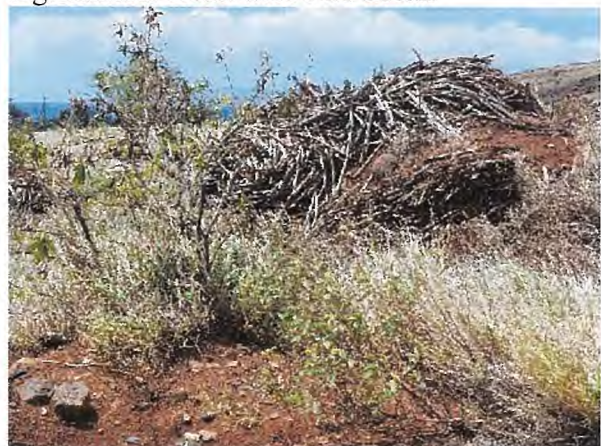
Old Sugar Cane Piled Near Ma'alaea Stream

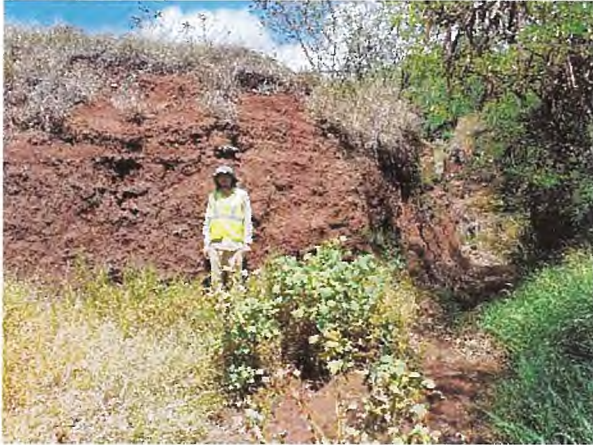
Head Cutting

This land is ideally situated for the implementation of a suite of projects that would benefit the Pohakea Watershed. These projects have been discussed in detail in Section 4 of this plan and include everything from head cut repair to detention basins to ideal locations for stormwater wells. In addition to providing locations for these projects, this parcel is situated in a highly accessible location along the highway, making it an ideal candidate site for parks and greenspace. Lastly, due to high winds and dry conditions, this area is prone to wildfires. Regardless of the type of any future land use, development should include stormwater

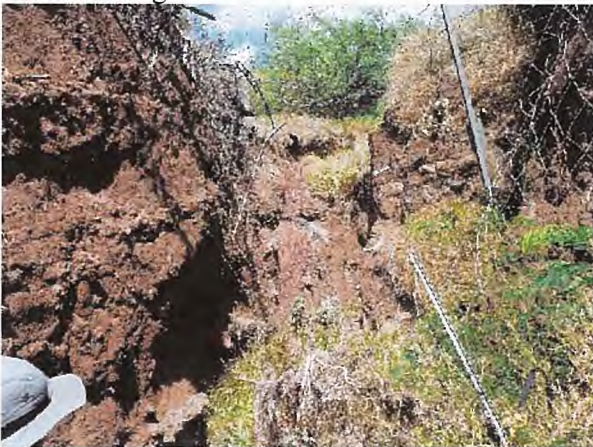
Channelization

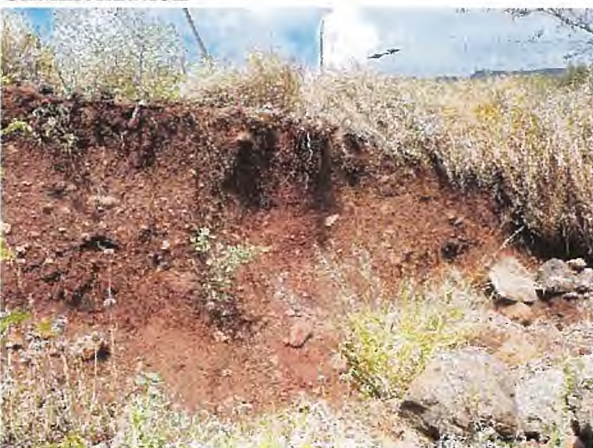
Head Cutting

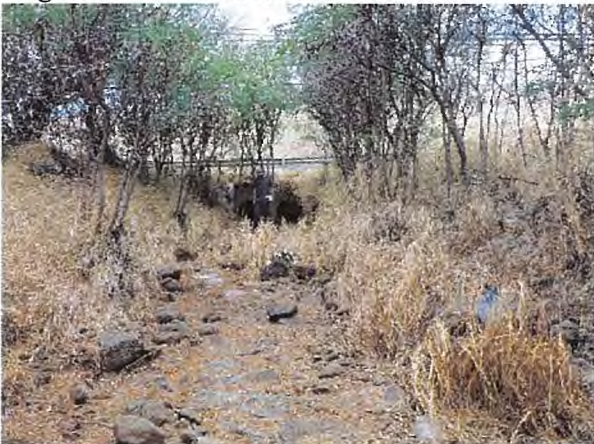
Unnamed Ditch

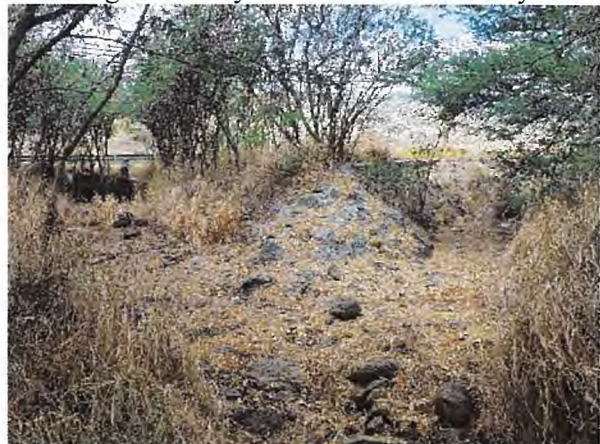
Confluence with Unnamed Ditch

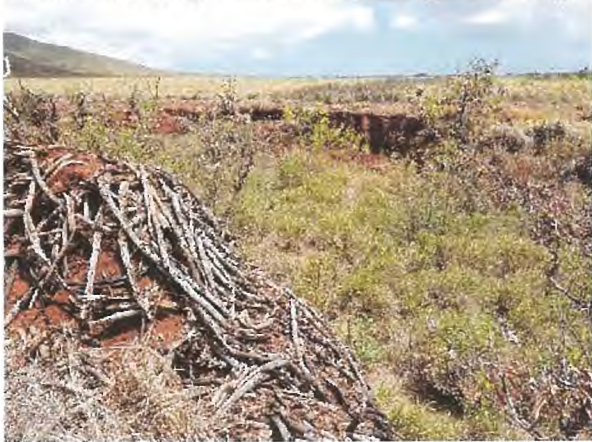
Sugar Cane Push Piles Near Gulch

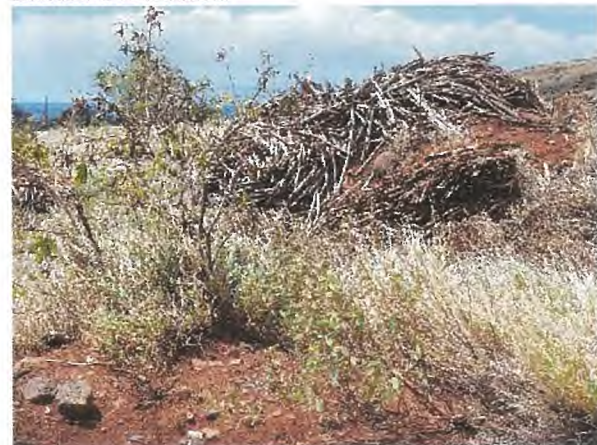
Sugar Cane Push Piles Near Gulch
