Structural Condition Analysis and Assessment of Dormitory Facilities

December 17, 2019

Site Located at 820 Ka'ahumanu Avenue, Kahului, Maui 96732 TMK: (2)3-8-07:117

Summary of Structural Field Condition Survey for the Existing University of Hawaii Community College Dorm Campus Buildings and Appurtenances

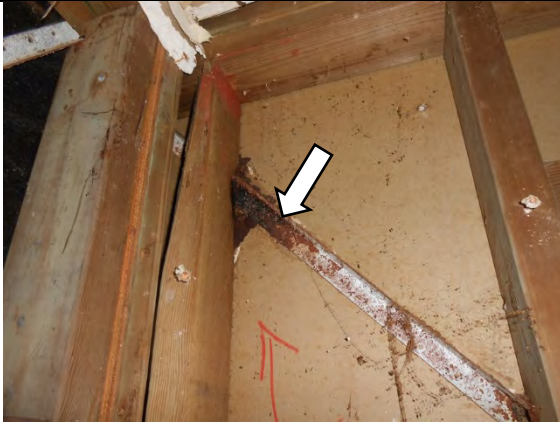
PA1D.1: Typically, metal wall braces exhibit minor to moderate rust.

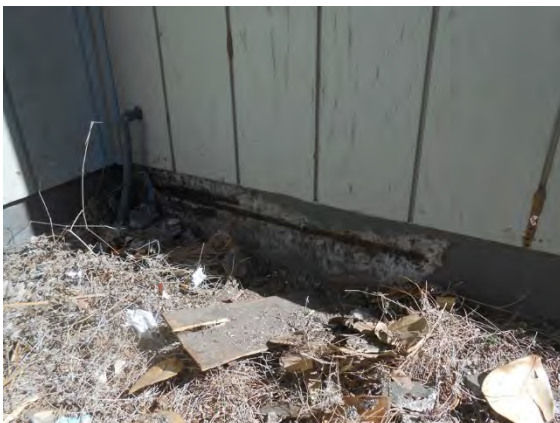
PA1D.2: At various locations, exterior foundation wall face is spalled with exposed corroded reinforcing steel.

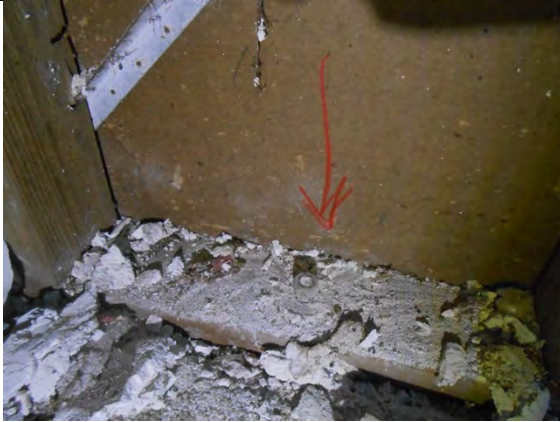
PA1CD.1: At various locations, sole plate anchor rods nuts are loose.

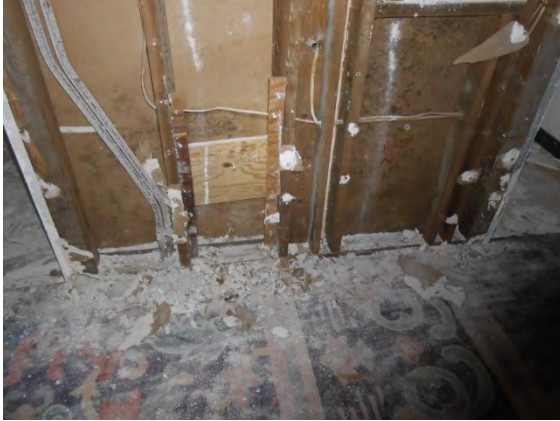
At various locations, interior wall sole plate anchor rods are missing or installed with spacing greater than 32" on-center.

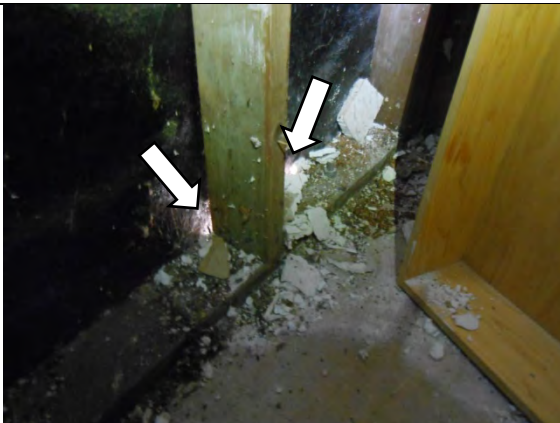
PA1CD.2: Daylight observed at base of wall.

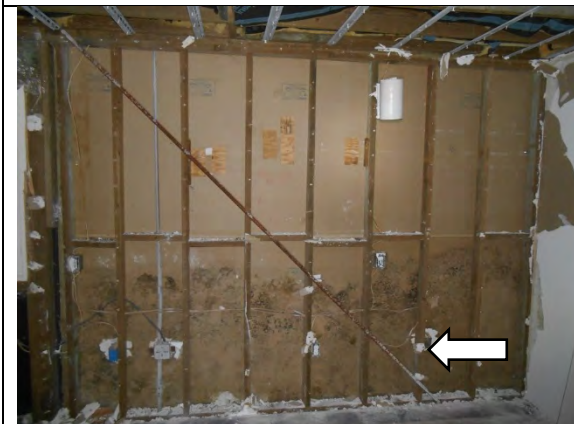
PA1CD.8: Discontinuous stud.

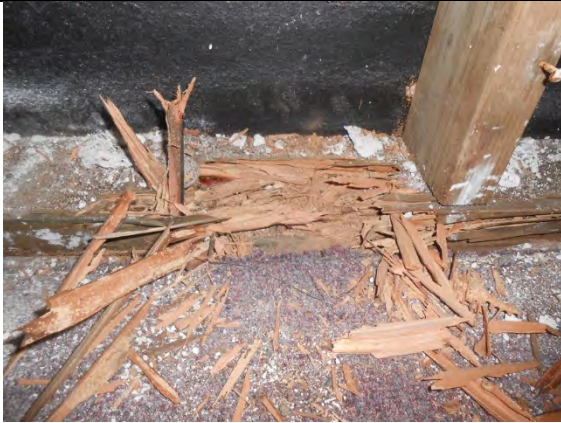
PB1D.1: Sole plate dry rot.

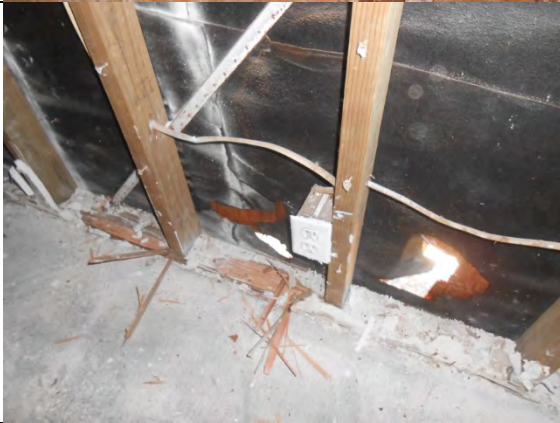
PB2D.2: Sole plate dry rot.

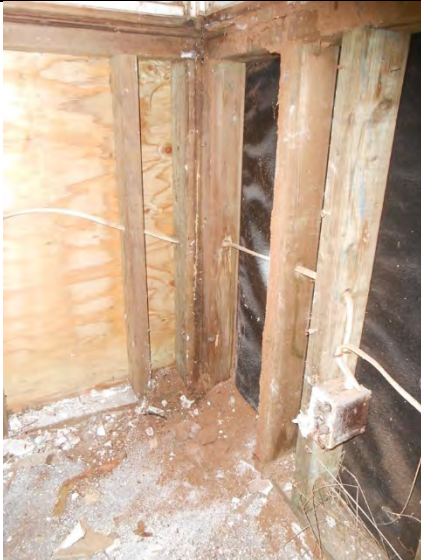
PC1D.6: Termite mud tracks on member surfaces.

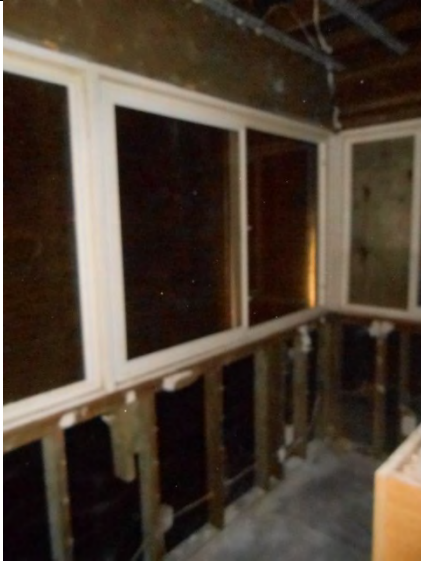
PC1CD.2: Wide opening with single sill plate.

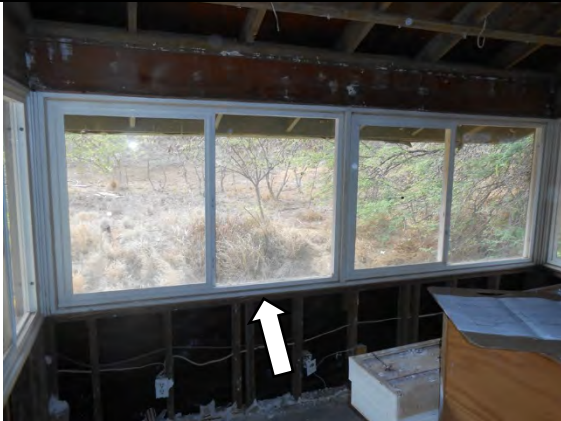
PC2CD.2: Wide opening with single sill plate.

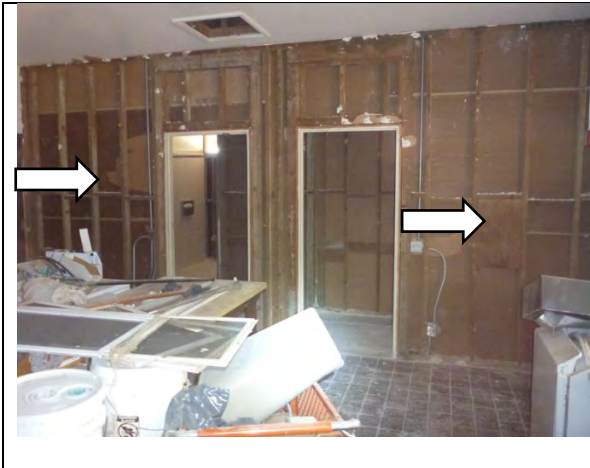
RC1CD.3: At various locations, let-in braces are not installed as shown per the original structural drawings.

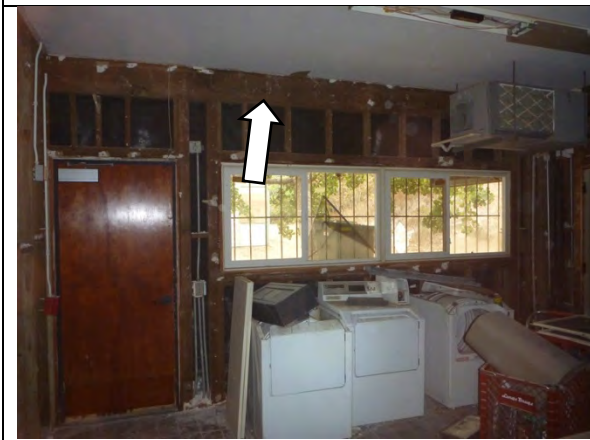
RC1CD.4: At various locations, headers are installed as continuous members spanning over multiple openings. The original drawings specify an individual member over each opening.

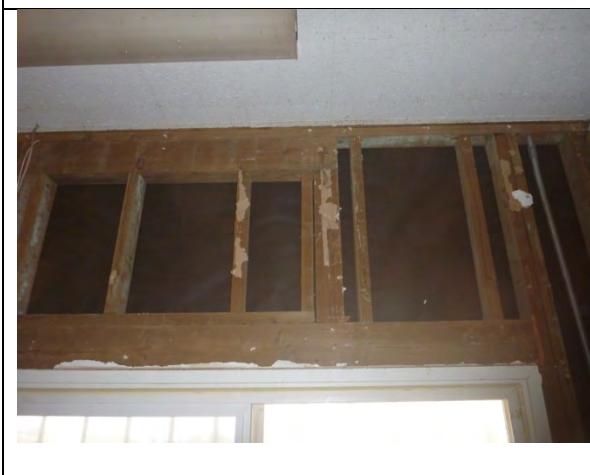
RCICD.5: Odd framing above office window.

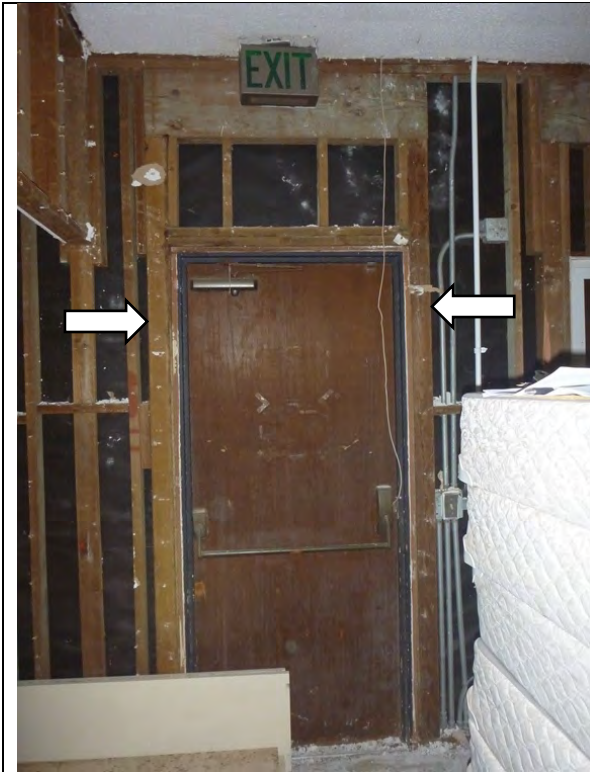
RCICD.6: At various locations, scab (aka king post) is not installed against the jamb post as specified per the original structural drawings.
