**SUBJECT: COUNTY-OWNED PARCEL ON NORTH PAPA AVENUE (KAHULUI)
(AH-8)**

Structural Condition Analysis and Assessment of Dormitory Facilities

December 17, 2019

Site Located at 820 Ka'ahumanu Avenue, Kahului, Maui 96732 TMK: (2)3-8-07:117

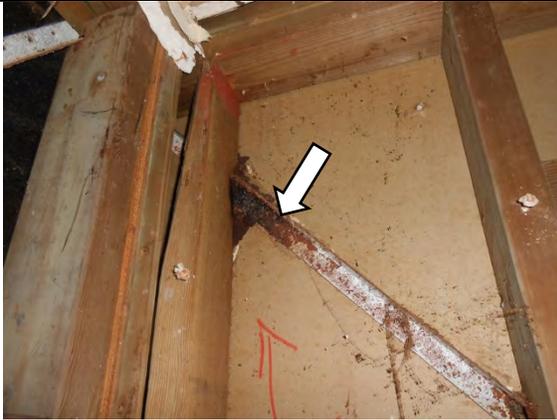
PA1D.1: Typically, metal wall braces exhibit minor to moderate rust.

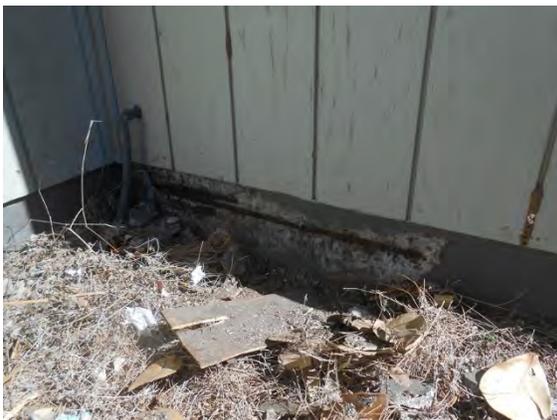
PA1D.2: At various locations, exterior foundation wall face is spalled with exposed corroded reinforcing steel.

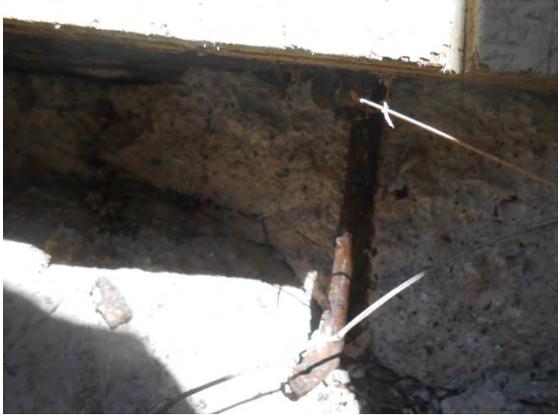
PA1D.3: Concrete spall with exposed corroded sole plate anchor rod.

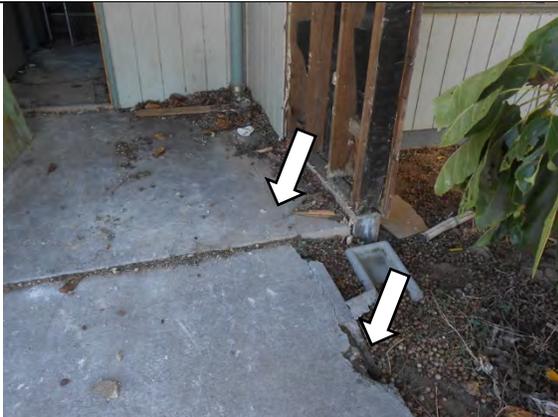
PA1D.5: Cracked exterior slab at rusting drain-pipe.

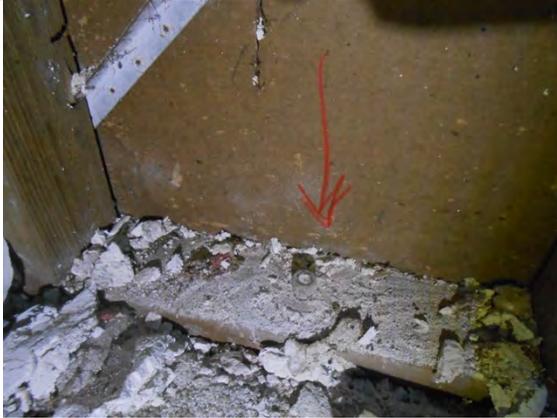
PA1CD.1: At various locations, sole plate anchor rods nuts are loose.

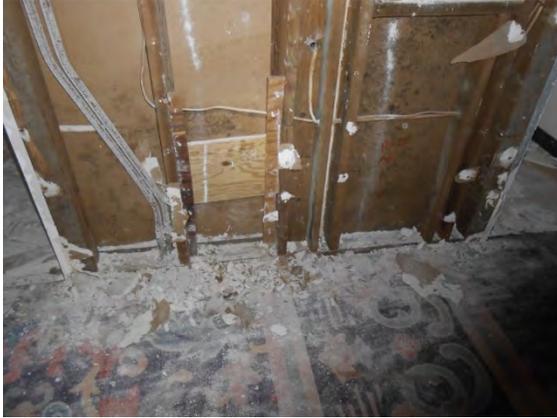
At various locations, interior wall sole plate anchor rods are missing or installed with spacing greater than 32" on-center.

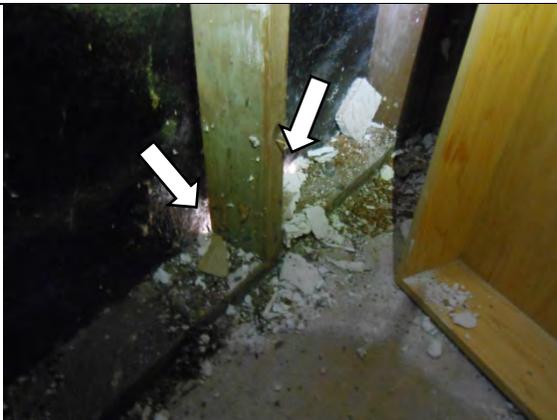
PA1CD.2: Daylight observed at base of wall.

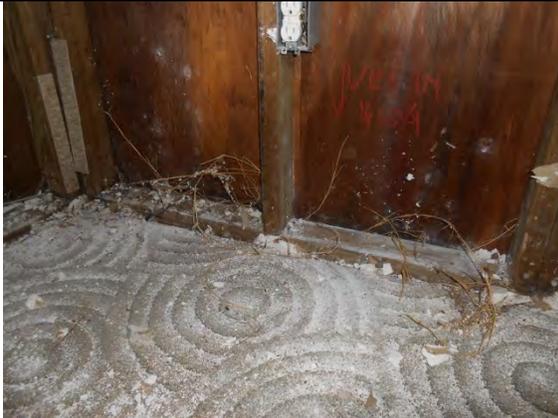
PA1CD.3: At various locations, vegetation is present at interior face of first story walls.

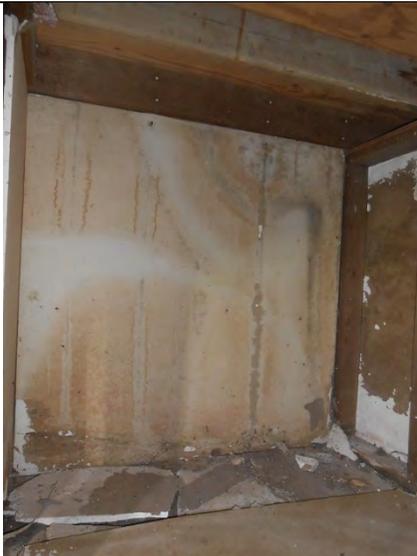
PA1CD.5: Stud wall framing not in-place beneath stair landing at exterior wall.

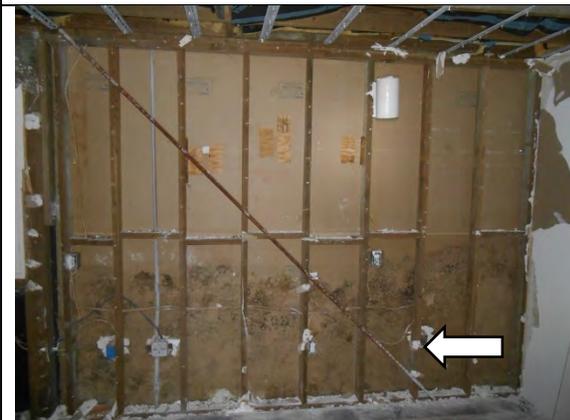
PA1CD.8: Discontinuous stud.

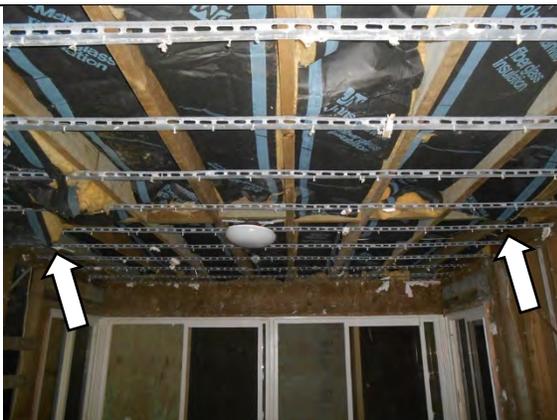
PA2CD.3: Missing wall blocking.

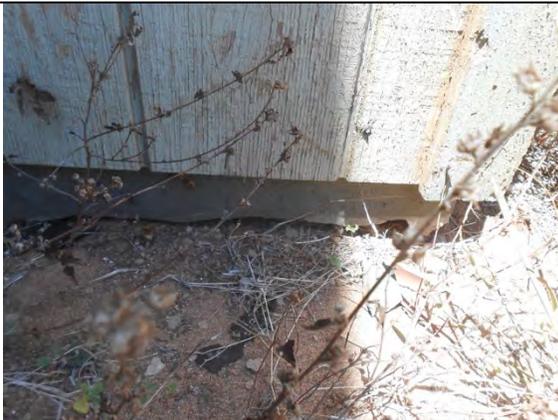
PB1CD.5: Exposed bottom of footing.

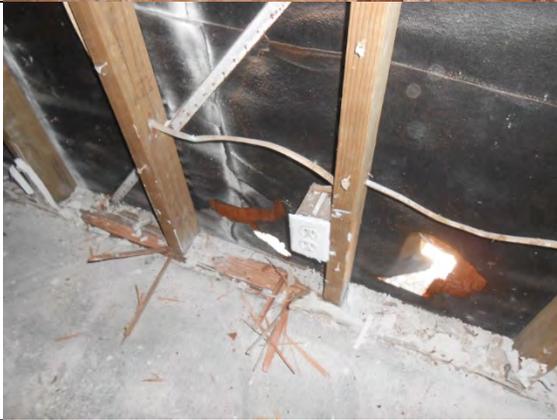
PB2D.2: Sole plate dry rot.

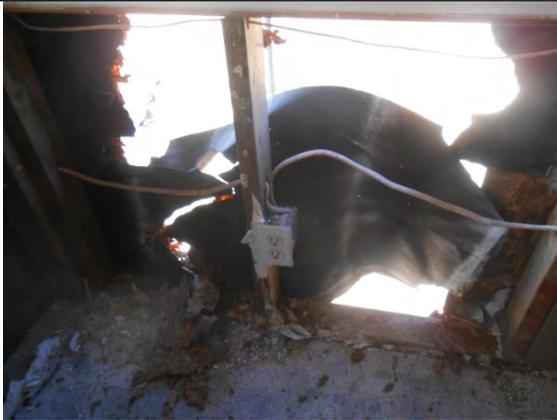
PB2D.3: Sheathing dry rot.

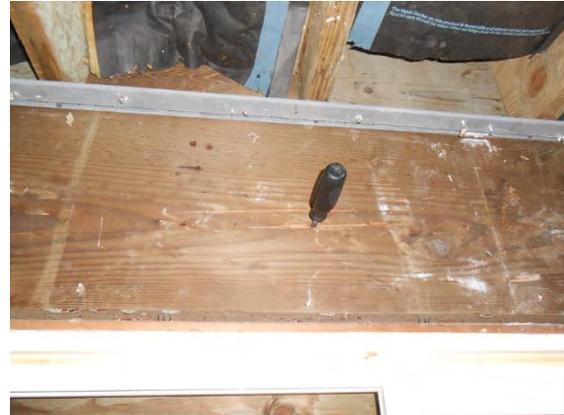
PC1D.3: Siding dry rot.

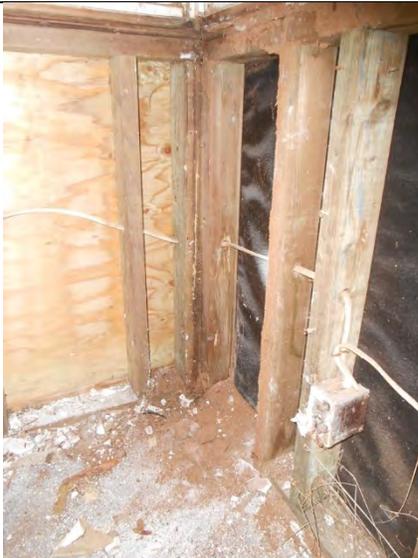
PC1D.6: Termite mud tracks on member surfaces.

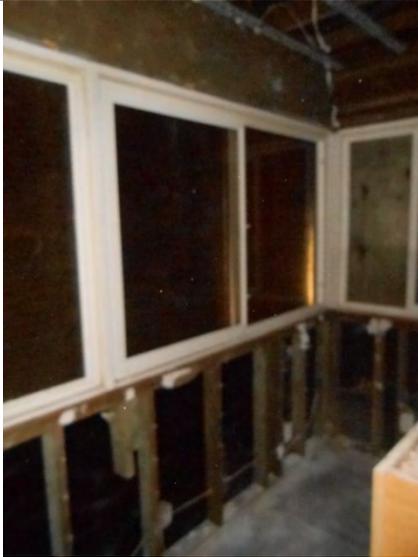
PC1CD.2: Wide opening with single sill plate.

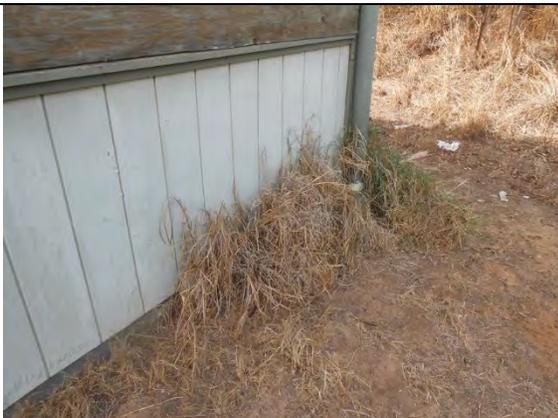
PC1CD.3: At various locations, vegetation against building façade.

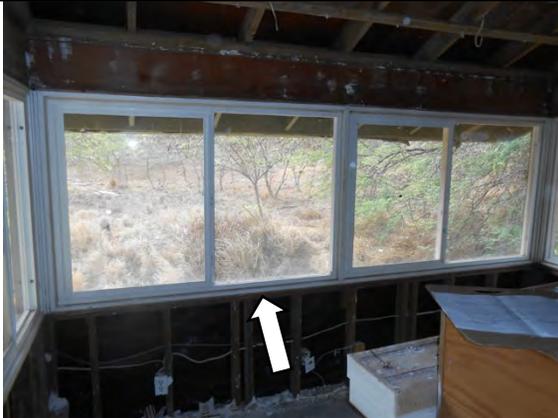
PC2CD.2: Wide opening with single sill plate.

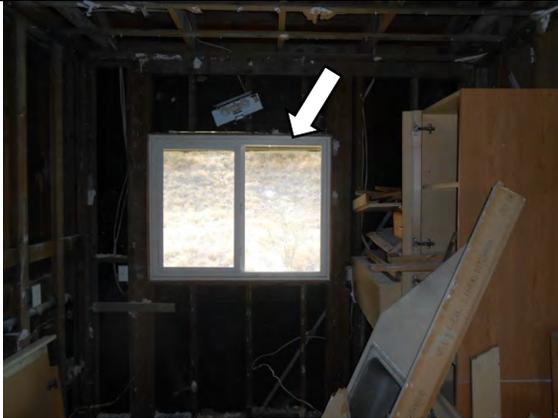
PC2CD.4: Missing opening header.

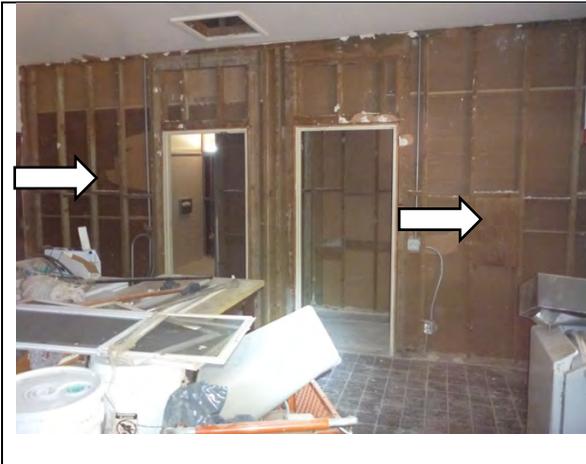
RC1CD.3: At various locations, let-in braces are not installed as shown per the original structural drawings.

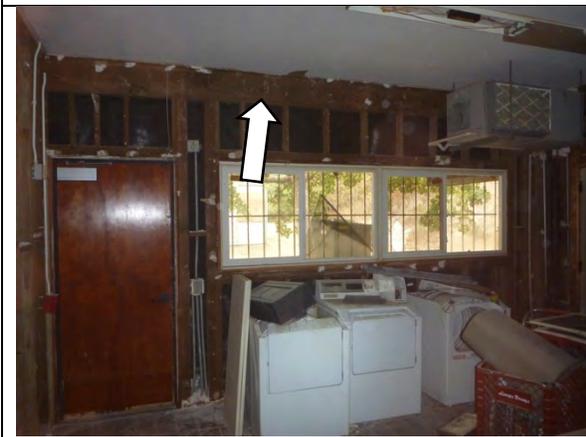
RC1CD.4: At various locations, headers are installed as continuous members spanning over multiple openings. The original drawings specify an individual member over each opening.

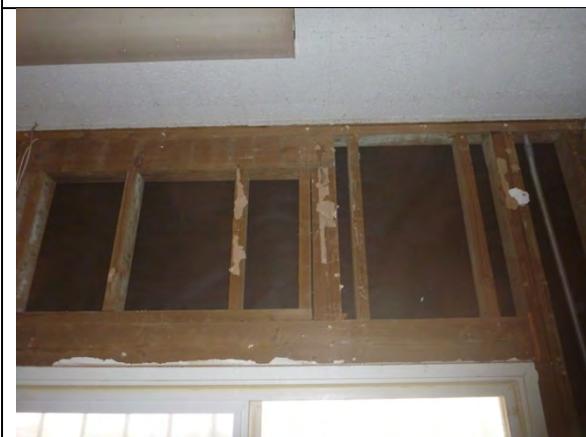
RCICD.5: Odd framing above office window.

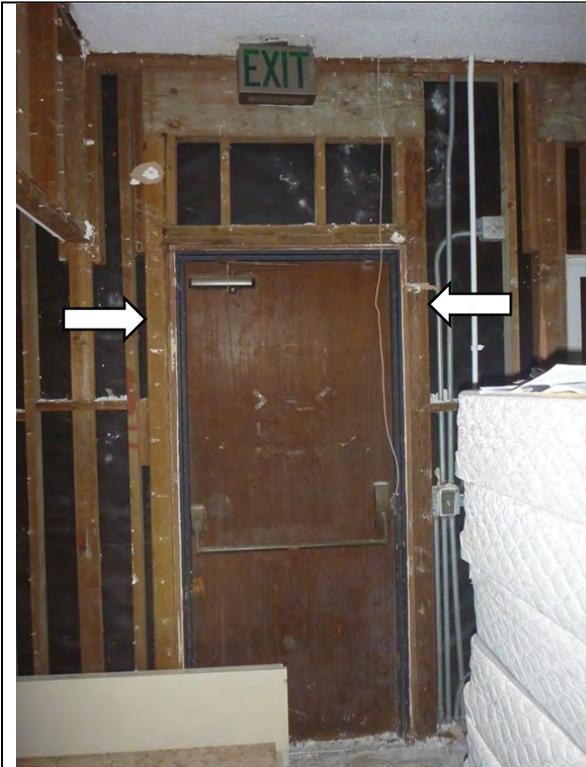
RCICD.6: At various locations, scab (aka king post) is not installed against the jamb post as specified per the original structural drawings.

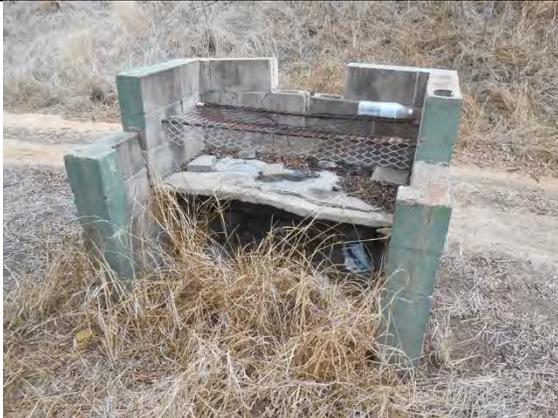
PBP1: Damaged concrete masonry unit barbecue pit. Missing blocks, cracked masonry, and warped concrete fire slab.

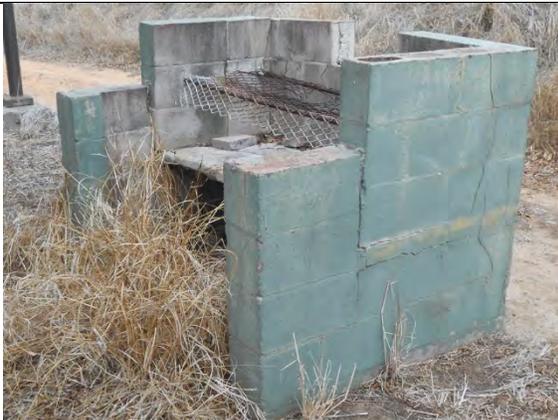
PBP2: Damaged concrete masonry unit barbecue pit. Missing blocks, cracked masonry, and warped concrete fire slab.

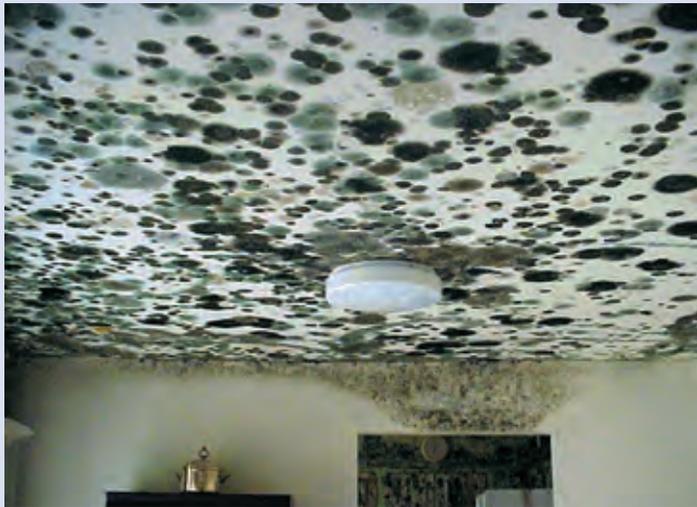
Photo 2: Extensive mold contamination of ceiling and walls

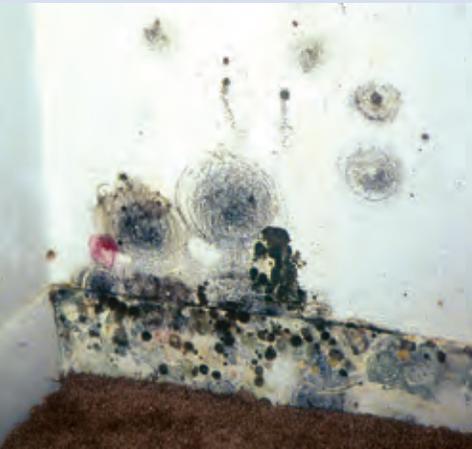
Photo 3A: Mold growing in closet as a result of condensation from room air

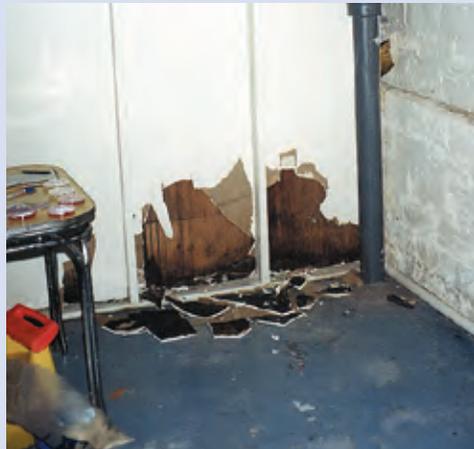
Photo 3B: Front side of wallboard looks fine, but the back side is covered with mold

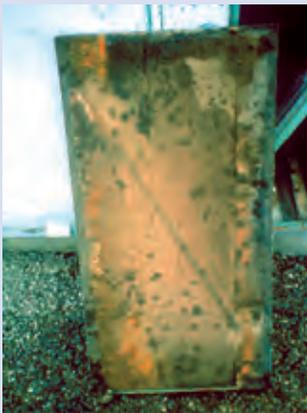
Photo 4A: Contaminated fibrous insulation inside air handler cover

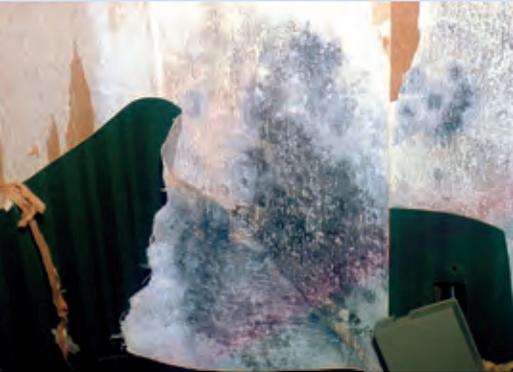
Photo 5: Mold growth behind wallpaper

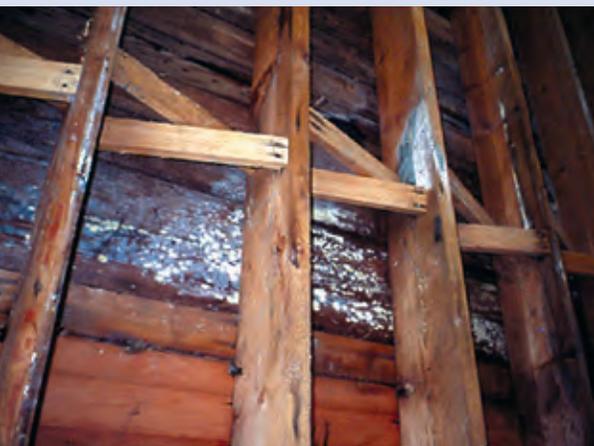
Photo 6: Heavy mold growth on underside of spruce floorboards
